# Barge or tjalk? A wreck investigation in the tidal flats of North Frisia

We present a case study on the applicability of geophysical methods to map shipwrecks in the coastal zone. We present results of magnetic gradiometry, electromagnetic induction, and photogrammetry.

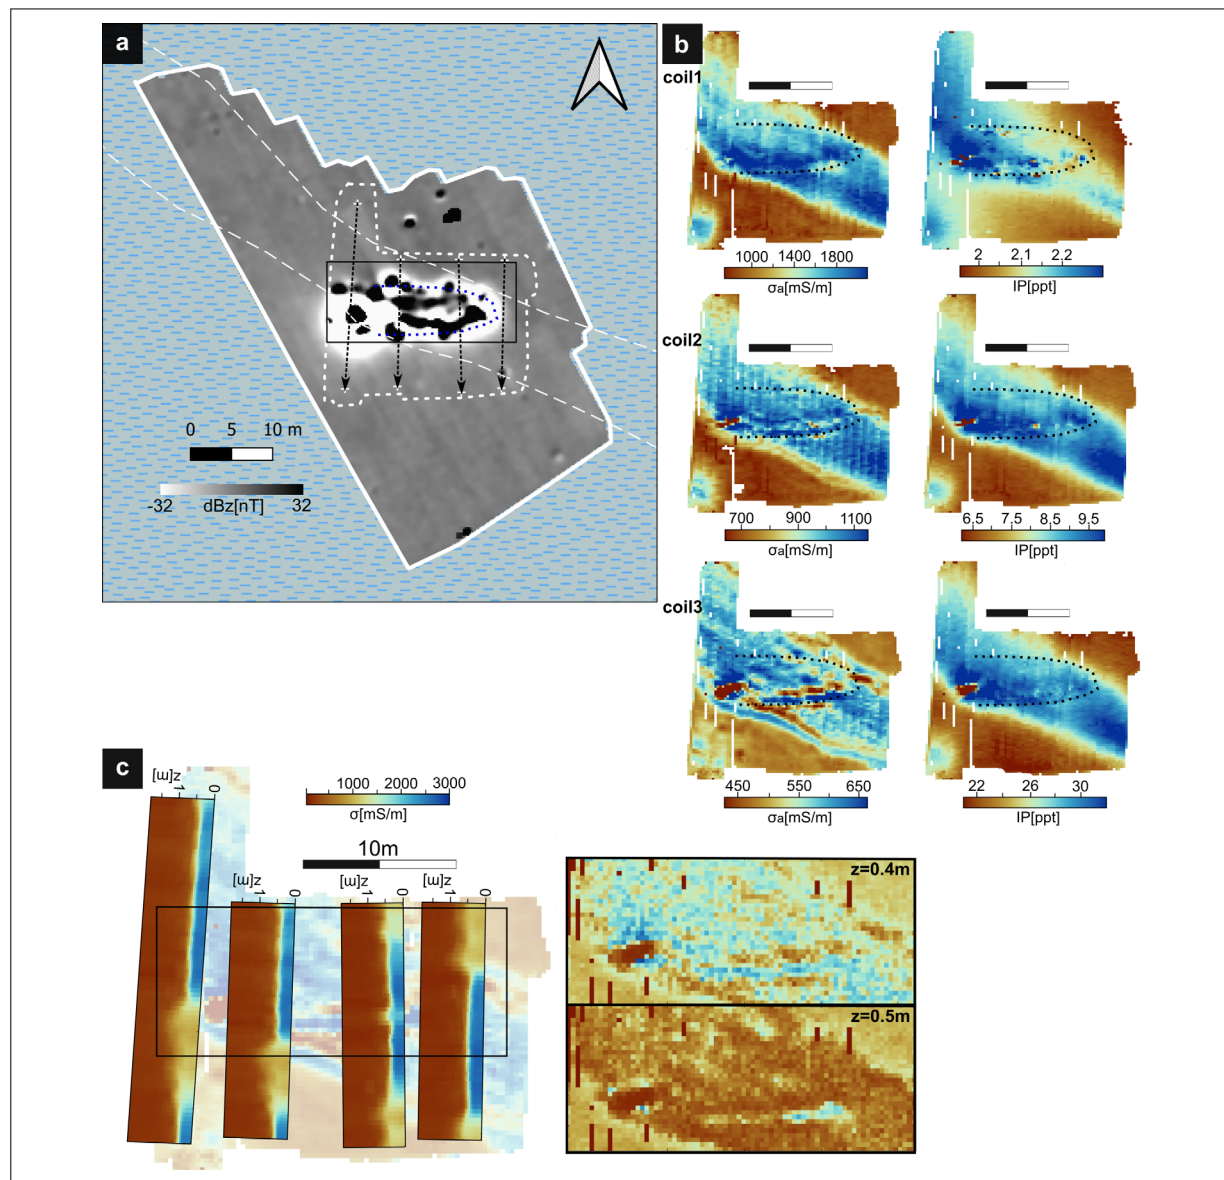
**Fig. 2:** a) Magnetic gradiometry map. Dashed white lines indicate the EMI area and the tidal creek. Black solid line and dashed lines indicate the area and profiles of 1D EMI conductivity inversions. b) Apparent conductivity and In-Phase (IP) maps of the three different coil separations. c) Inverted conductivity profiles (left) and depth slices through pseudo 3D conductivity cube (right).

Figure 2 shows the results of the geophysical measurements. In Figure 2a the magnetic gradiometry map is shown in the 32 nT range, showing the outline of the

wreck in terms of magnetic signal. Figure 2b shows the apparent conductivity and In-Phase (IP) maps of the three different EMI coil separations. The outline of the magnetic feature is shown as black dotted line, framing visible signals from the wreck. Figure 2c shows example profiles and depth slices of the conductivity. The most striking structure visible in the profiles is the waterbody of the tidal creek with typical conductivities of up to 3000 mS/m. Wreck features appear strongest, where surface finds are still present in the water column.

The gradiometry furthermore allows a containment of the whole wreck even for its northern, submerged side. Though an estimation of the ship's total length and width is possible being about 20 m by 6 m. This length is in the typical range of a tjalk. On the western side of the wreck, a strong magnetic anomaly as well as an IP and conductivity anomaly is observed, highlighting the stern knee and its wooden and (submerged) metal components. If this is the stern of the ship, large metal components could indicate a rudder hinge.

Due to the strong influence of the tidal creek on the EMI data, it shows only few indications of wreck remains beyond the surface finds. Although IP data of e.g. medium coil separation show weak indication of the northern edge of the wreck. The construction wood itself, if remaining in the subsoil, is not observed as clear as for example in Wilken et al. (2022a), who showed a clear signal of wooden wreckage in a more sandy tidal flat area, that is dry during low tide. In the present case more silty subsoil and water running down the tidal creek recommends a combination of gradiometry and EMI. A geophysical prospection and a feasible recording methodology of such archaeological features are of high interest in tidal flat areas, as
